Causes of pavement failure of Edunabon – Sekona road, Osun State, Nigeria

Department of Civil Engineering, Obafemi Awolowo University, Ile-Ife, Nigeria

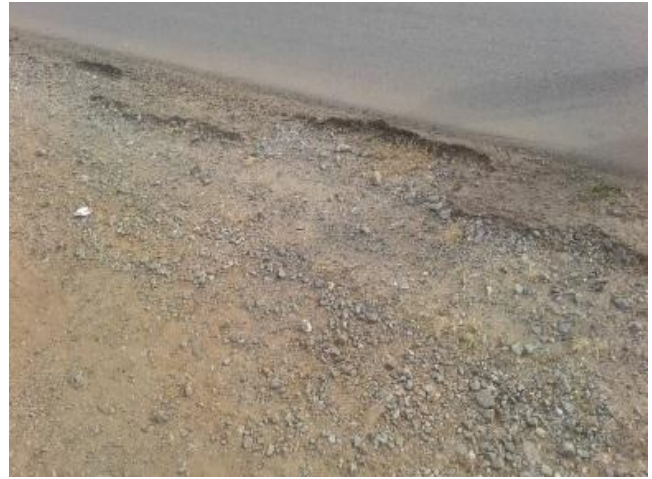
(a) Edge and Shoulder Damage

Plate 2. Failures at CH. 0+000 – 0+500

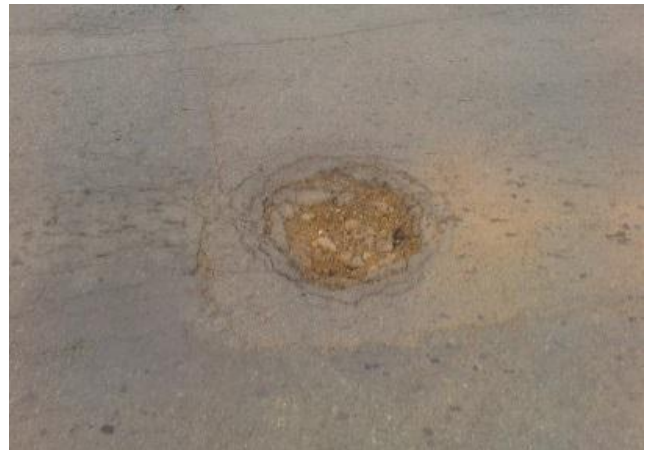
(b) Pothole

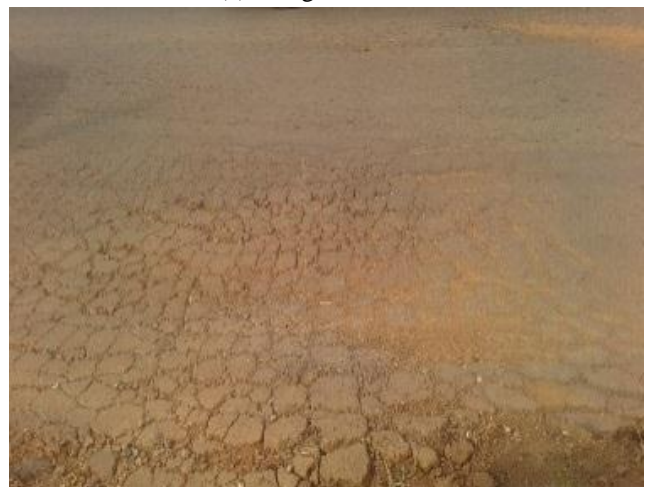
(c) Alligator Cracks

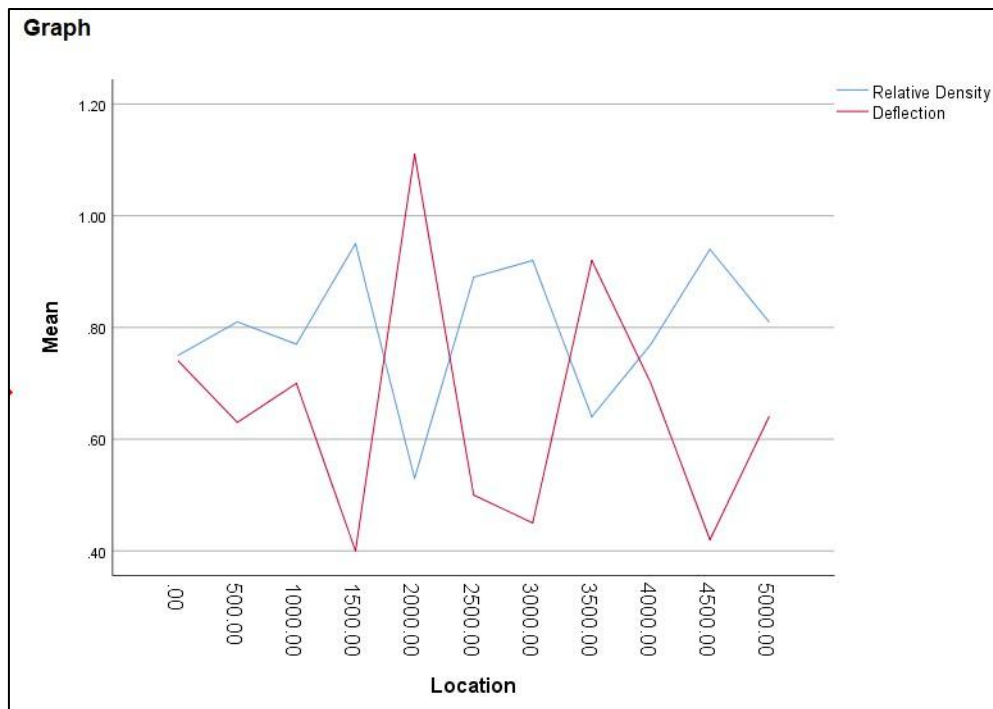
Fig 1. Relative Densities and Deflections of Route

The deflection and relative density graphs for the route are shown in Figure 1. It shows the relationship between the relative density and the deflections. The average deflection value for the route is 0.66 mm, while its representative rebound deflection value is 1.10 mm. Using the template in Table 3 [18], the pavement has failed. The template is based on minimum relative density (RD) of 95 % for embankment construction by [13], and 100 % relative density (RD) specification by Federal Ministry of Works and Housing, 1997 [18].
